CHARACTERISATION OF THE DOUNREAY CASTLE SITE USING THE GROUNDHOG SYSTEM

TECHNOLOGY

Site	Dounreay Castle, Caithness, Scotland (ND 983670)
Problem	Presence of radioactive contamination due to past operations
Key objectives	To establish the magnitude of the problem, the nature of the contamination and its extent and severity
Objectives	<ul style="list-style-type: none">● Provide data for risk assessment and safety case● Determination of remediation method(s)● Integrated approach to site characterisation● As a post remediation assurance tool

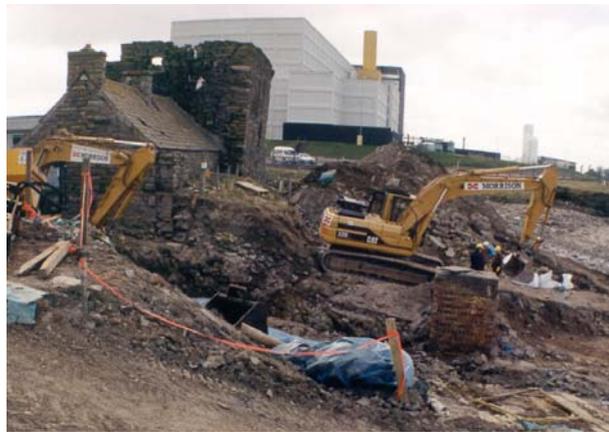
In close co-operation with a specialist archaeological contractor, the ground around the Castle was carefully excavated in slices of 20cm depth. This method allowed the safe removal of contaminated material and a detailed recording of the site archaeological history. The initial stage of the remedial works is shown in Figure 3. Remediation works completed during 1998 allowed open access to the site for the first time in 40 years (Figure 4).

Figure 3 *Beginning the remediation of Downreay Castle*

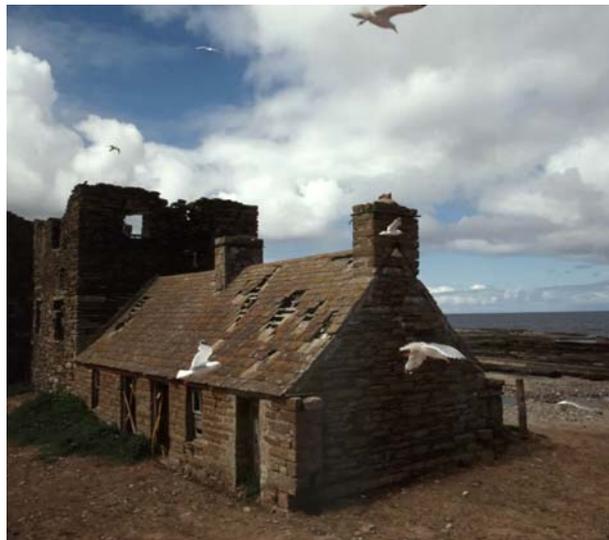
Figure 4 *Downreay Castle after remediation*
